# **Lessons not Learned from the Fukushima Accident**

## **Risks of the European NPPs**

**10 years later**

Study commissioned by Greenpeace

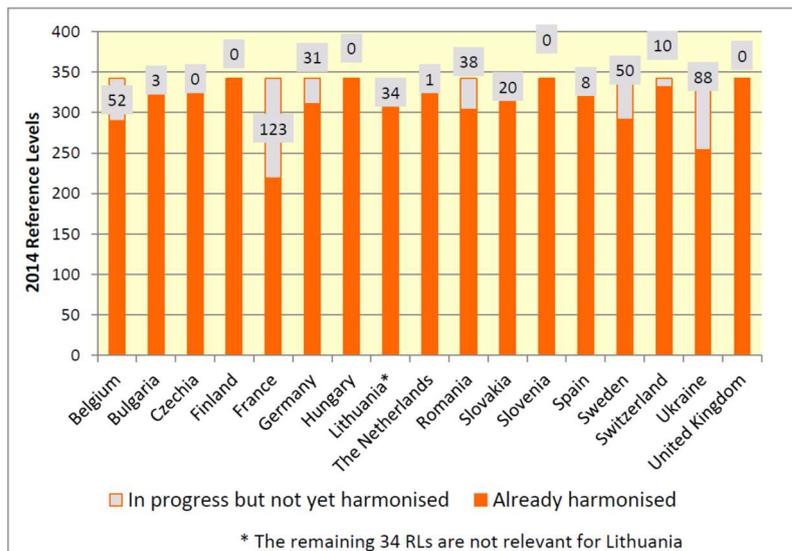
Figure 1: Reported status of implementation of 2014 RL in 2020 (WENRA RHWG 2020a)

WENRA RHWG (2020a) reports on the implementation of the revised RLs in the national regulatory frameworks of WENRA countries.

If the Reference Levels, which reflect the safety requirements learned from the accident in Fukushima, are not implemented in the regulations, the operators are not obliged to retrofit the plants accordingly. The plant is then considered "safe" in the respective country because it meets the outdated safety requirements in the regulations.

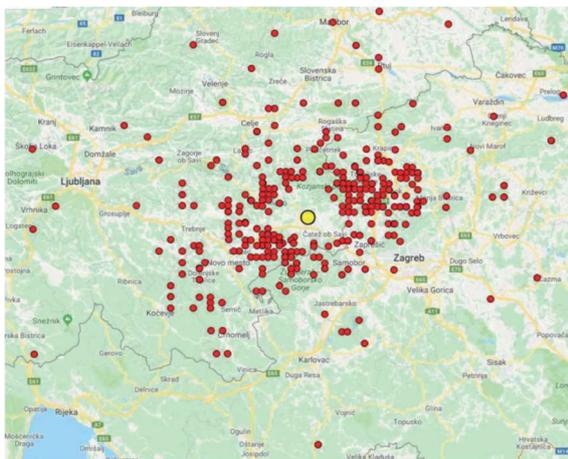
*Figure 2: Maximum distances for necessary evacuation after a severe accident at the Krško NPP(JOE 2019)*

While Croatia does not have a NPP on its territory, it co-owns the NPP Krško in Slovenia which is 10 km away from the Croatian border. Croatia needs to include the NPP Krško in comprehensive hazard assessment. A recent article presents hazard assessment based on calculations using RODOS.<sup>12</sup> Results from hundreds of calculations have been statistically analyzed and compared to the current protection zones in Croatia around the NPP Krško.(JOE 2019)

On the Croatian side an Urgent Protective Action Zone (UPZ) is set up to the distance of 20 km from the NPP Krško. This is the zone where evacuation plans should be set up. The analysis shows that the current UPZ covers only about 30% of cases where evacuation is needed. Evacuations of the population should be undertaken before the arrival of the cloud to protect from cloud-shine, from inhalation during the passage of radioactive cloud and from ground-shine. (JOE 2019)

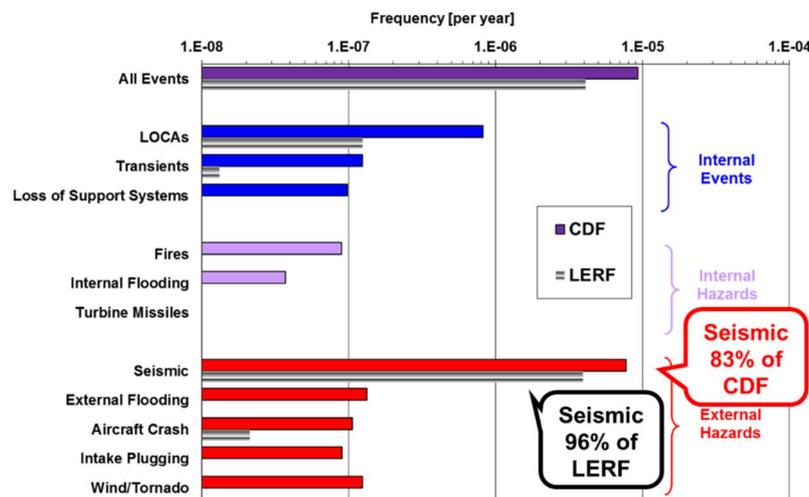
Figure 3 Core damage frequency (CDF) und Large early releases frequency (LERF) at Beznau NPP (Status 2015)(RICHNER 2015)

The operator of the Beznau NPP submitted the revised PSA level 1 and 2 at the end of 2013 as part of the periodic safety review to ENSI. The analysis already takes into account the retrofit with the project AUTANOVE. The PSA study for power operation calculates an average core melt frequency (CDF) of about  $1 \cdot 10^{-5}$  per year ( $9.35 \cdot 10^{-6}$  per year).<sup>24</sup> The calculated accident probabilities are relatively high compared to other nuclear power plants. This confirms the lower safety level of Beznau due to design deficits that cannot be retrofitted. The following graph illustrates the contributions of initiating events in the frequency of core damage and severe accidents with large and early releases.

It is noteworthy that an earthquake contributes 83% to the CDF and 96% to the frequency of a large and early release. Should an earthquake trigger a core melt accident, it will result in high and early releases in almost all cases. This means that the releases are so large that the population would have to be evacuated, but there is not enough time to do so.
